**The restoration of Giotto's
Wall Paintings in the
Scrovegni Chapel of Padua
according to the principles
of Cesare Brandi's Theory**

1. Brief conservation history and some notes on preliminary studies for the recent restoration project
2. Notes on the main causes of deterioration and the principal areas affected by loss of pictorial text
 - 2.1. abrasions
 - 2.2. lacunae
3. How lacunae were reintegrated during previous restorations
4. Cesare Brandi's Theory of Restoration and the reconstruction of the pictorial text during the latest restoration

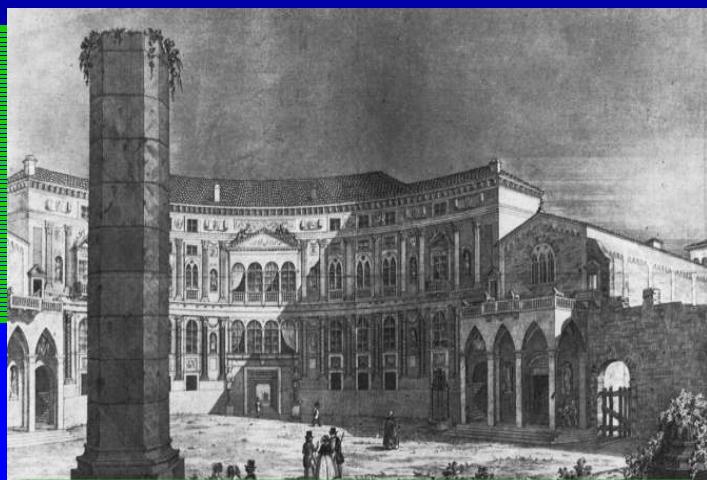
*Padua, civic museum - Fioravanti Penuti: Scrovegni chapel and the Palace, incision from a drawing
of Alessandro Buzzacarini 1842.*

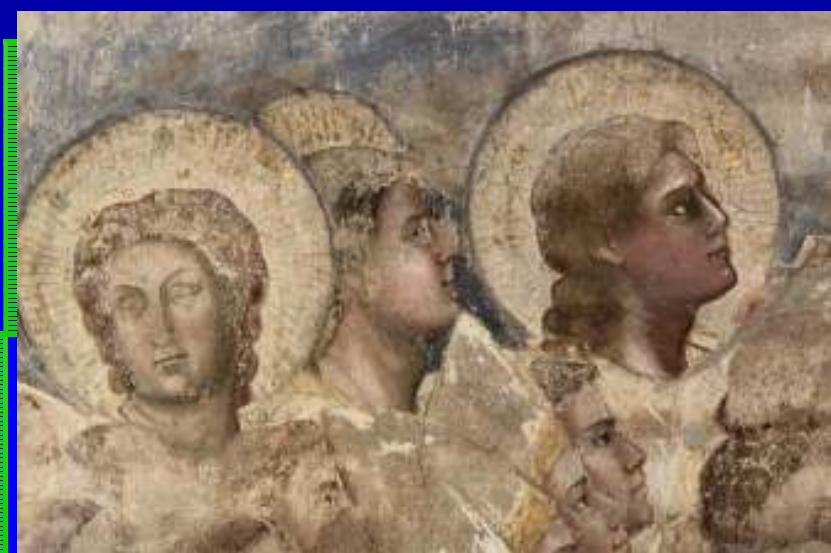
2. Notes on the main causes of deterioration and the principal areas affected by loss of pictorial text (abrasions)

the phenomenon is, however, also evident in the area where the vault, left wall and triumphal arch come together (Mary's wedding procession, starry sky and decorative bands, Mission of archangel Gabriel), due to defects in the roof.

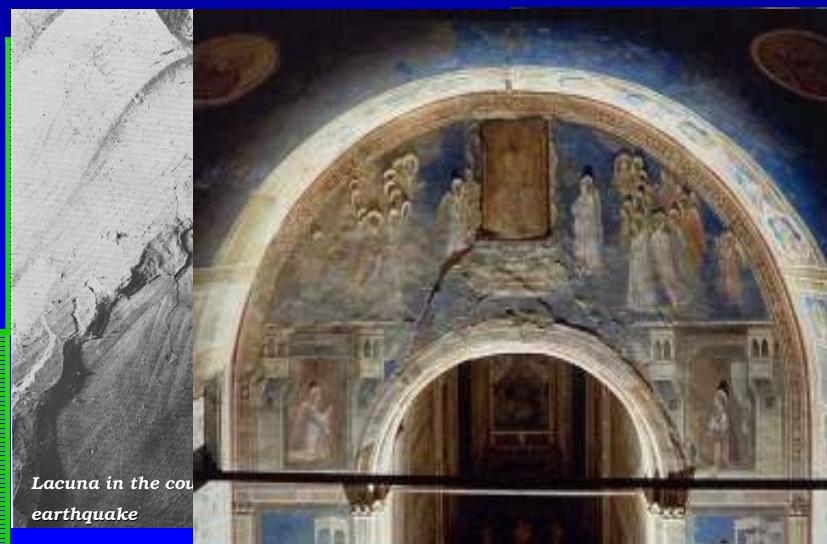
Also in the triumphal arch, lower left, there are two large lacunae, probably due to an earlier insertion of architectural elements that were later removed.

Over the years, the Chapel suffered serious static stress due both to its particular architectural configuration and its location, and to the building history of the complex to which it belongs. These factors were further compounded by a succession of exceptional events, such as bombardment and earthquakes. They were the cause of the fall of portions of the plaster, but fortunately affected a relatively low percentage of the painted surface. They are located principally in the area of the triumphal

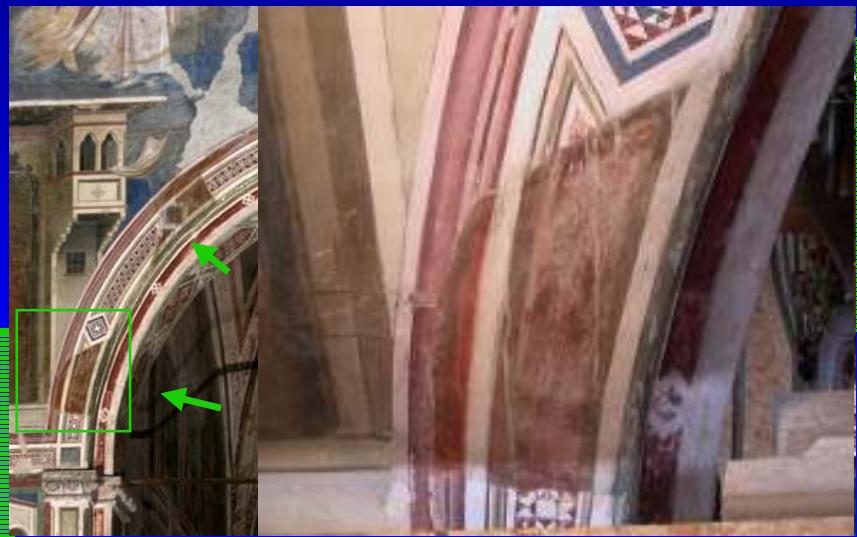
3. How lacunae were reintegrated during previous restorations : Botti e Bertolli

Numerous areas were stuccoed by Botti and Bertolli during the nineteenth-century restorations. They used a lime-sand mix that was very similar to the original, and reintegrated the surface with colored areas suggesting the volumes of the painted figures and architectural elements, following the indications given by Cavalcaselle, who was then a member of the above-mentioned scientific committee established in 1867.

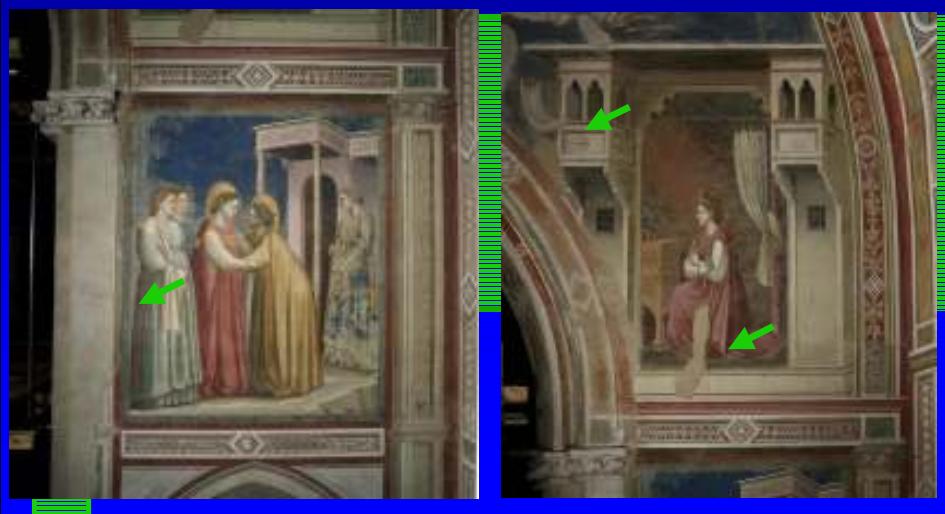
3. How lacunae were reintegrated during previous restorations : Tintori

There is a heavy presence of stuccoes carried out by Leonetto Tintori during the treatment performed between 1957 and 1963. In many places he removed

the surface mortar of the previous stuccoing, replacing it with a mix of sand bound with synthetic resin; in two cases the mix was spread on Masonite board cut in the outline of the lacuna concerned. One of these, in particular, involved the robe of the Virgin in the “Annunciation”. In his notes, Leonetto Tintori documents the presence of sinopia visible in the plaster underneath. In fact, he states that following the removal of the stuccoing Botti had done in that area, he saw the sinopia of the Virgin’s foot (from the typewritten report of LEONETTO TINTORI, entitled: Giotto nella Cappella degli Scrovegni a Padova, Raccolta dei rilievi Tecnici Sull’Arte ed il Mestiere del Maestro, on page 64 we read: “*Dalla figura della Vergine, in un tempo precedente ai restauri del Botti, era malauguratamente caduto un frammento di intonaco, coinvolgendo un piede dell’Annunciata. Botti, dopo aver consolidato i bordi della caduta, ne aveva riempito il vuoto con una malta nuova. Nel restauro del 1961 questa malta è stata rimossa perché fatiscente e sotto è stato trovato il piede disegnato in rosso sull’arriccia, il che fa pensare che Giotto, prima di affrescar, definisse le sue composizioni con un tracciato di sinopia.*”). Nonetheless, several elements make this statement doubtful.

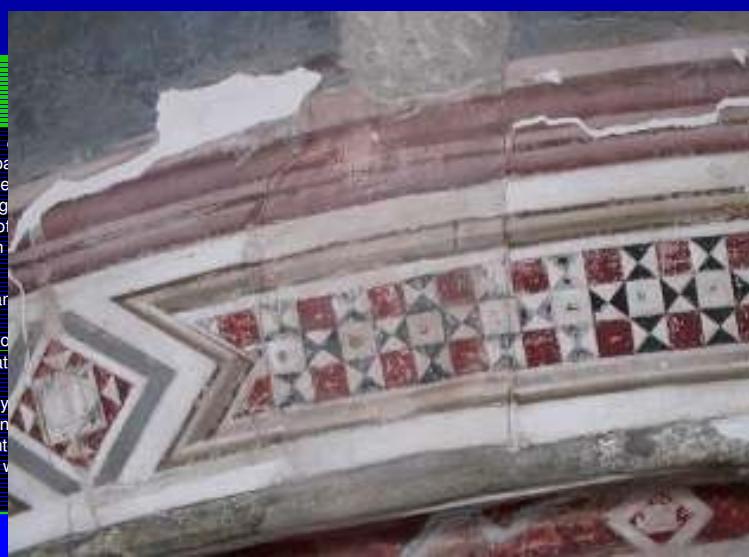
A few years ago, that is, during the campaign some of the more important repairs.

For example, marked "Vecchio Restorato" dated probably nineteen and Tintori, the two v-

For example, the reintegrations marked by the inscription “Vecchio Restauro” [“Old Restoration”] cannot yet be dated precisely, but they probably occurred between the nineteenth-century restoration and Tintori’s, perhaps between the two world wars.

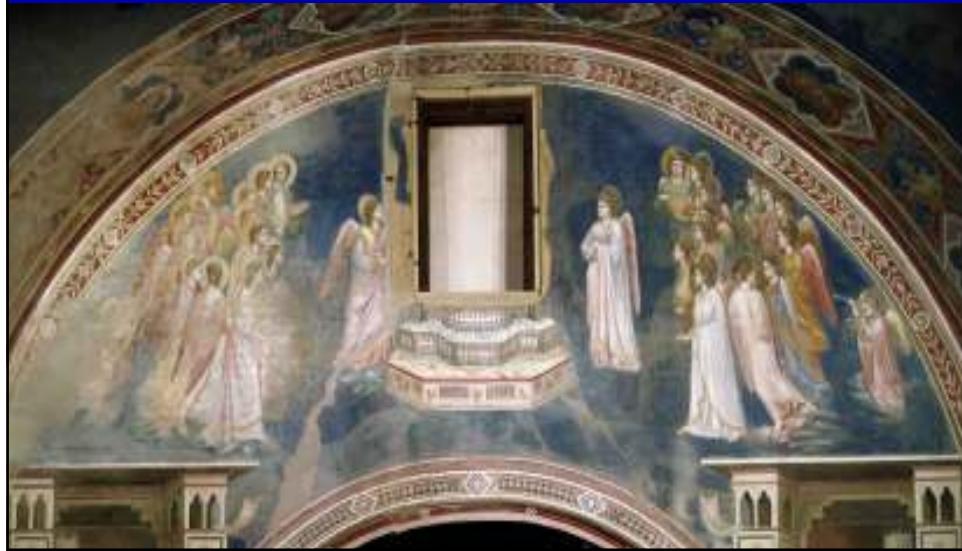
Balancing the blue backgrounds was a complex operation. The azurite painting, done "a secco" over a gray preparation, was very fragmentary throughout, especially in the scenes of the first register. The extensive lacunae exposed a situation that was chromatically discordant and far from the objective of unity sought by Giotto as previously described. The various giornate that often compose the broad azurite areas were frescoed with rapid gray paint strokes, which were neither particularly homogeneous nor all alike.
