## SALT LOAD AND DETERIORATION OF SANDSTONE AT THE TEMPLE OF ANGKOR WAT, CAMBODIA

### Abstract

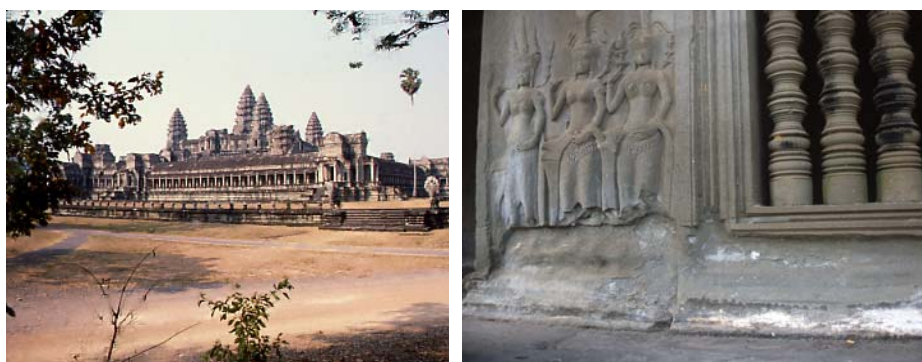
In many places the sandstone surfaces are affected by weathering. Contour scaling (fig. 1, right) and flaking are the most typical weathering forms. Salt efflorescence can

Fig. 1a, b: General view of the Angkor Wat temple from southeast (a, left) and detail with contour scaling of the sandstone and salt efflorescence in a gallery (b)

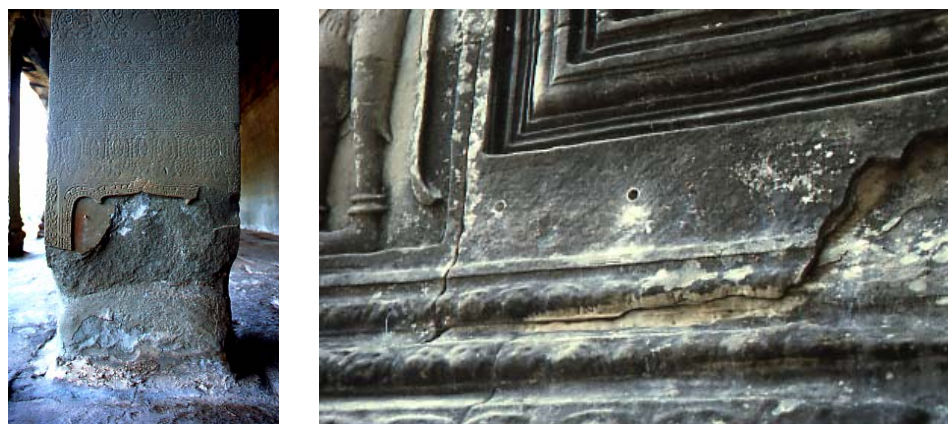
At two places with typical weathering forms a more detailed investigation was possible by taking drill core profiles in different positions from the surface to the depth. Drill cores AW I to AW IV were taken from a pillar in the open gallery of the third enclosure to the north at different height levels (see figs. 2 and 4a). Another two drill cores (AW V and VI) were taken from a surface with contour scaling near the eastern entrance of the second enclosure (figs. 2 and 4b).

Fig. 4 a, b: Pillar from the northern gallery of the third enclosure (a, left) and surface with contour scaling (b, right)
